F-4-49 Ramsburg-Gaver Farmstead Myersville Frederick County

# Maryland Historical Trust State Historic Sites Inventory Form

1. Nam	1e (indicate pre	eferred name)		
historic Ran	nsburg-Gaver Farmste	ad (preferred)		
and/or common	Shelter Rock Far	m		
2. Loca	ation			
street & number	4234 Crow Rock R	oad		_ not for publication
city, town	Myersville	_X vicinity of	congressional district	6th
state Mar	ryland	county	Frederick

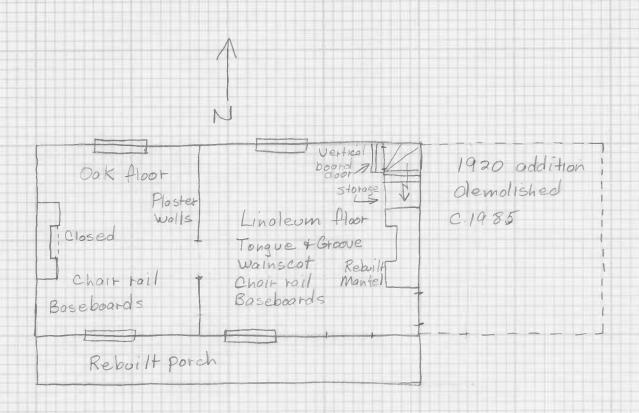
F-4-49
Ramsburg-Gover Formstead
Frederick County

Log
House
House
Sinter of Summer
Summer
Kitchen Smokehouse

Crow Rock Road
Wogon Barn
Shed/
Chicken House/ Wogon Shed/
Chicken House/ Blacksmith/ Cohn Chib
Feed Shed

Springhouse

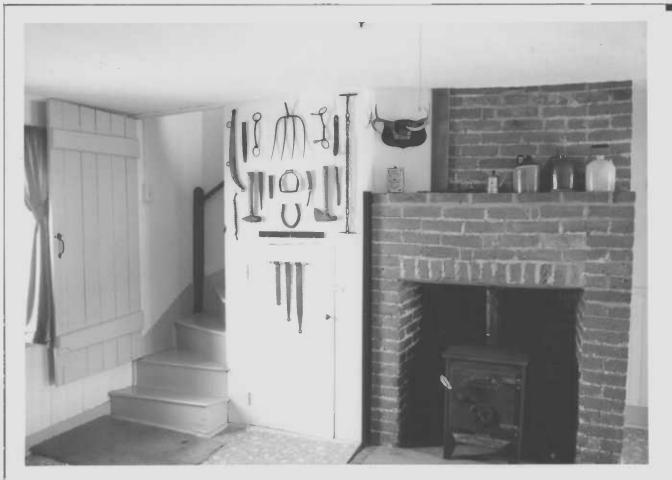
Frederick County Photo Touch Dans Ridden freplace and ste

The interior plan features two rooms on both stories, with a stairway in the northeast corner. The interior walls are plastered and the east room has a tongue-and-groove wainscot below a simple molded chair rail. The floor in this room is covered with linoleum. The brick fireplace has been rebuilt in an approximation of the original and has a wood stove in the opening. Between the opening and the stairway is an enclosed storage closet with whitewash on the interior walls. The west room or parlor has random width oak floors, molded baseboards, and the same molded chair rail as in the east room. The mantelpiece is a simple, vernacular style loosely based on Greek Revival designs with sections of reeding at the narrow shelf. The second floor contains two rooms and a small hall at the top of the stairway. The ceiling has been dropped somewhat from the original height to allow for insulation. The walls are also plastered with baseboards and chair rails. The

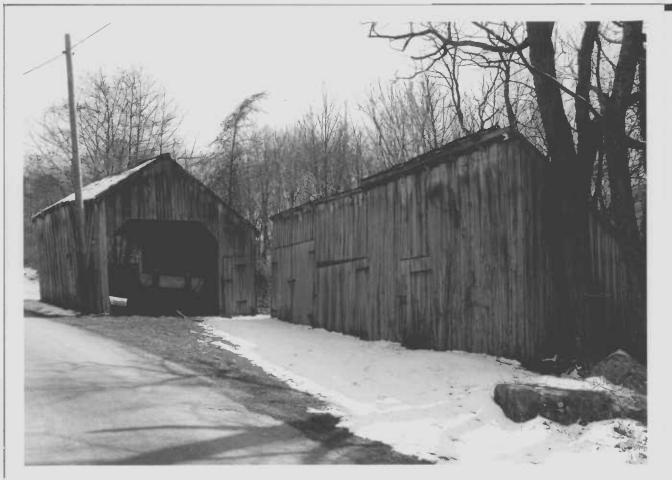
F-4-40 Ramsburg - End Farms 1 21 Frederick Courty Warran Stall Corn (1) = , Den and , Wagen shed

Wagon shed/corn crib: The wagon shed/corn crib is located immediately east of the second group of three adjoining structures. It has vertical siding and a single corn crib on the south side. The roof is corrugated metal. Its date is probably 1875-1900.
